## **Asbestos Register Review 2025**

**Company name:** Kimmeridge Close Residents Company Limited

**Date review was carried out:** 09/01/2025

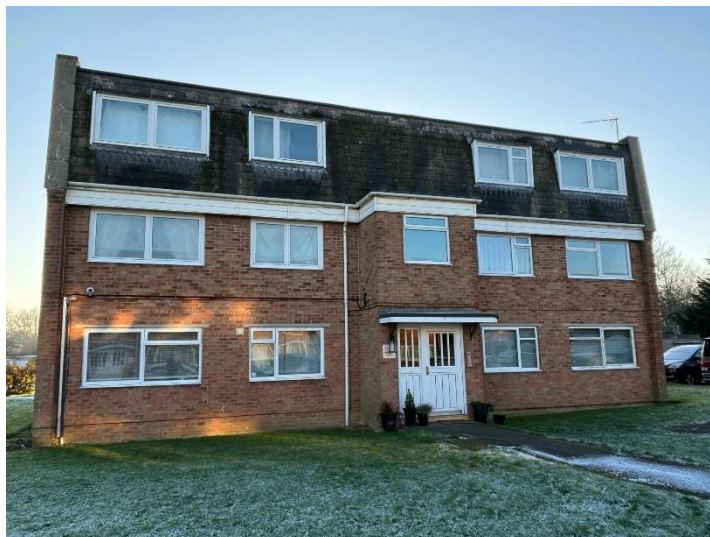
**1-6 Kimmeridge Close, Nythe, Swindon, SN3 3PZ**

Asbestos Register Summary					Review	
Floor	Location	Asbestos Containing Material	Type	M.A.S	Condition	Action
Ground	Entrance Hall	Ceiling – Textured Coating	Chrysotile	2	Good	Leave and manage
Ground	Entrance Hall	Floor tiles and adhesive	Chrysotile	3	Removed and carpet laid	None
Ground	Electrical Cupboard	Insulation board above door	Chrysotile	7	Good	Repair/ Encapsulate
1 <sup>st</sup>	Stairs and Landing	Ceiling – Textured Coating	Chrysotile	2	Good	Leave and manage
1 <sup>st</sup>	Stairs and Landing	Floor tiles and adhesive	Chrysotile	3	Removed and carpet laid	None
2 <sup>nd</sup>	Stairs and Landing	Ceiling – Textured Coating	Chrysotile	2	Good	Leave and manage
2 <sup>nd</sup>	Stairs and Landing	Floor tiles and adhesive	Chrysotile	3	Removed and carpet laid	None
External	External	Roof (hanging tiles)	Chrysotile	3	Fair	Leave and manage
External	External	Roof insulation board soffit below hanging tiles	Chrysotile	6	Fair	Leave and manage

External	External	Porch ceilings to rear entrance	Chrysotile	4	Good	Leave and manage
External	External	Mastic around door	Chrysotile	3	Encapsulated by new door	None
External	External	Front Porch ceiling panel	Chrysotile	4	Good	Leave and manage

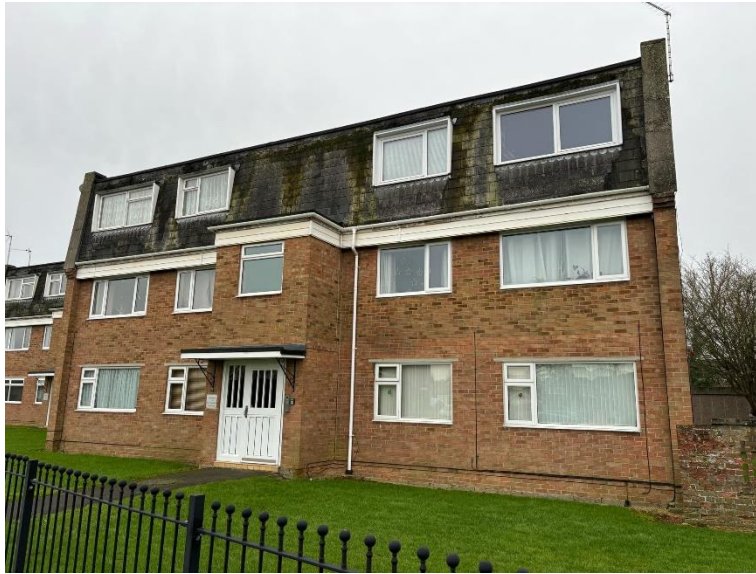
**7-12 Kimmeridge Close, Nythe, Swindon, SN3 3PZ**

Asbestos Register Summary					Review	
Floor	Location	Asbestos Containing Material	Type	M.A.S	Condition	Action
Ground	Entrance Hall	Ceiling – Textured Coating	Chrysotile	2	Good	Leave and manage
Ground	Entrance Hall	Floor tiles and adhesive	Chrysotile	3	Removed and carpet laid	None
Ground	Electrical Cupboard	Insulation board above door	Chrysotile	7	Good	Repair/ Encapsulate
1 <sup>st</sup>	Stairs and landing	Ceiling – Textured Coating	Chrysotile	2	Good	Leave and manage
1 <sup>st</sup>	Stairs and landing	Floor tiles and adhesive	Chrysotile	2	Removed and carpet laid	None
2 <sup>nd</sup>	Stairs and landing	Ceiling – Textured Coating	Chrysotile	3	Good	Leave and manage
2 <sup>nd</sup>	Stairs and landing	Floor tiles and adhesive	Chrysotile	2	Removed and carpet laid	None
External	External	Roof (hanging tiles)	Chrysotile	3	Fair	Leave and manage
External	External	Roof insulation board soffit below hanging tiles	Chrysotile	6	Fair	Leave and manage

External	External	Mastic around door	Chrysotile	3	Encapsulated by new door	None

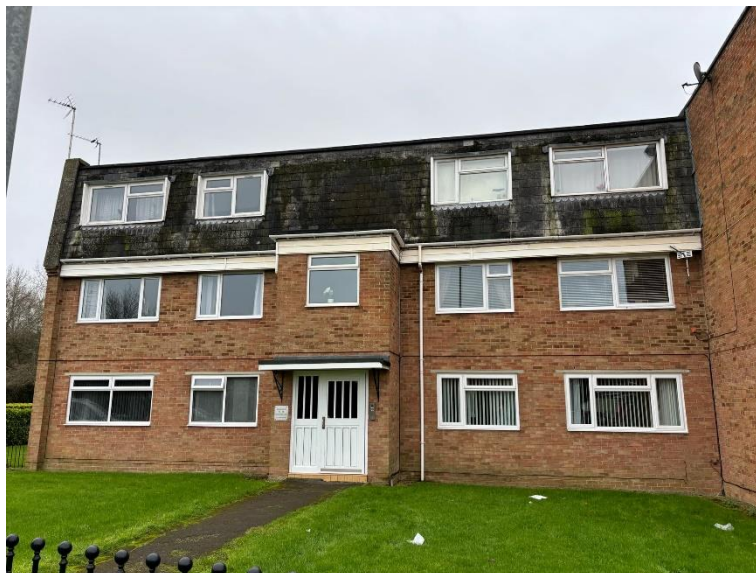
**13-18 Kimmeridge Close, Nythe, Swindon, SN3 3PZ**

Asbestos Register Summary					Review	
Floor	Location	Asbestos Containing Material	Type	M.A.S	Condition	Action
Ground	Entrance Hall	Floor below carpet	Chrysotile	2	Removed and carpet laid	None
Ground	Electric Cupboard	Ceiling – Textured Coating	Chrysotile	2	Good	Leave and manage
Ground	Electric Cupboard	Insulation board above door	Chrysotile	7	Good	Repair/ Encapsulate
1 <sup>st</sup>	Stairs and landing	Ceiling – Textured Coating	Chrysotile	2	Good	Leave and manage
1 <sup>st</sup>	Stairs and landing	Floor below carpet	Chrysotile	2	Removed and carpet laid	None
2 <sup>nd</sup>	Stairs and landing	Ceiling – Textured Coating	Chrysotile	2	Good	Leave and manage
2 <sup>nd</sup>	Stairs and landing	Floor below carpet	Chrysotile	2	Removed and carpet laid	None
External	External	Roof (hanging tiles)	Chrysotile	3	Fair	Leave and manage
External	External	Roof below hanging tiles cement soffit	Chrysotile	3	Fair	Leave and manage

External	External	Mastic around door	Chrysotile	2	Encapsulated by new door	None

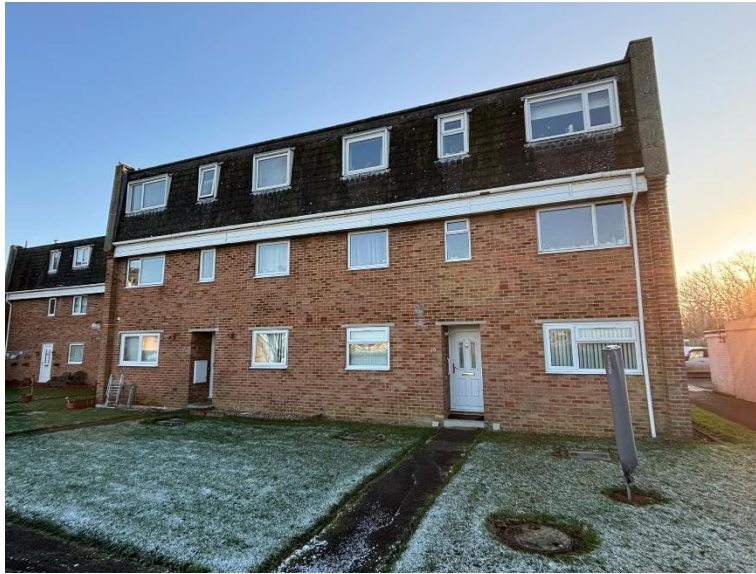
**19-24 Kimmeridge Close, Nythe, Swindon, SN3 3PZ**

Asbestos Register Summary					Review	
Floor	Location	Asbestos Containing Material	Type	M.A.S	Condition	Action
Ground	Entrance Hall	Ceiling – Textured Coating	Chrysotile	3	Fair	None
Ground	Entrance Hall	Floor tiles and adhesive	Chrysotile	4	Removed and carpet laid	None
Ground	Electrical Cupboard	Insulation board above door	Chrysotile	7	Good	Repair/ Encapsulate
1 <sup>st</sup>	Stairs and landing	Ceiling – Textured Coating	Chrysotile	2	Fair – Repair required by cupboard	Repair/ Encapsulate
1 <sup>st</sup>	Stairs and landing	Floor tiles and adhesive	Chrysotile	3	Removed and carpet laid	None
2 <sup>nd</sup>	Stairs and landing	Ceiling – Textured Coating	Chrysotile	2	Good	Leave and manage
2 <sup>nd</sup>	Stairs and landing	Floor tiles and adhesive	Chrysotile	2	Removed and carpet laid	None
External	External	Rood (hanging tiles)	Chrysotile	3	Fair	Leave and manage
External	External	Roof insulation board soffit below hanging tiles	Chrysotile	6	Fair	None

External	External	Mastic around door	Chrysotile	3	Encapsulated by new door	None

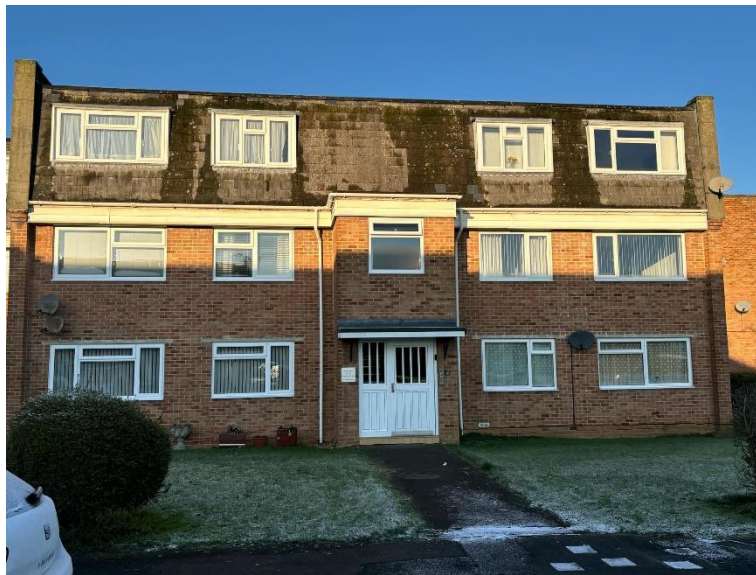
**25-30 Kimmeridge Close, Nythe, Swindon, SN3 3PZ**

Asbestos Register Summary					Review	
Floor	Location	Asbestos Containing Material	Type	M.A.S	Condition	Action
Ground	Entrance Hall	Ceiling – Textured Coating	Chrysotile	2	Good	Leave and manage
Ground	Entrance Hall	Floor tiles and adhesive	Chrysotile	3	Removed and carpet laid	None
Ground	Electrical Cupboard	Insulation board above door	Chrysotile	7	Good	Repair/ Encapsulate
1 <sup>st</sup>	Stairs and landings	Ceiling – Textured Coating	Chrysotile	2	Good	Leave and manage
1 <sup>st</sup>	Stairs and landing	Floor tiles and adhesive	Chrysotile	3	Removed and carpet laid	None
2 <sup>nd</sup>	Stairs and landing	Ceiling – Textured Coating	Chrysotile	2	Good	Leave and manage
2 <sup>nd</sup>	Stairs and landing	Floor tiles and adhesive	Chrysotile	3	Removed and carpet laid	None
External	External	Roof (hanging tiles)	Chrysotile	3	Fair	Leave and manage
External	External	Roof below hanging tiles cement soffit	Chrysotile	3	Fair	Leave and manage

External	External	Mastic around door	Chrysotile	3	Encapsulated by new door	None

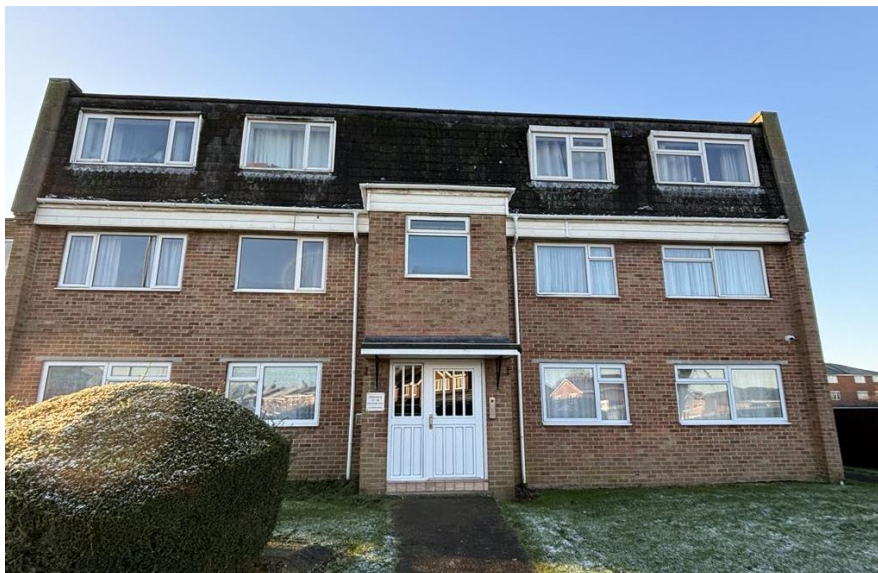
**31-36 Kimmeridge Close, Nythe, Swindon, SN3 3PZ**

Asbestos Register Summary					Review	
Floor	Location	Asbestos Containing Material	Type	M.A.S	Condition	Action
Ground	Entrance Hall	Ceiling – Textured Coating	Chrysotile	2	Good	Leave and manage
Ground	Entrance Hall	Floor tiles and adhesive	Chrysotile	3	Removed and carpet laid	None
1 <sup>st</sup>	Stairs and landing	Ceiling – Textured Coating	Chrysotile	2	Good	Leave and manage
1 <sup>st</sup>	Stairs and landing	Floor tiles and adhesive	Chrysotile	3	Removed and carpet laid	None
2 <sup>nd</sup>	Stairs and landing	Ceiling – Textured Coating	Chrysotile	2	Fair	Leave and manage
2 <sup>nd</sup>	Stairs and landing	Floor tiles and adhesive	Chrysotile	3	Removed and carpet laid	None
External	External	Roof (hanging tiles)	Chrysotile	3	Fair	Leave and manage
External	External	Roof below hanging tiles cement soffit	Chrysotile	3	Fair	Leave and manage
External	External	Mastic around door	Chrysotile	3	Encapsulated by new door	None
